A REFLECTION ON HOW THE DESIGN AND CONSTRUCTION  
OF WARRINGTON COMPRESSOR STATION WORKED IN PRACTICE 1988 to 2019

This article builds on the excellent paper by Charles Smith; British Gas Project Engineer for Warrington Compressor Station (“WCS”) during the design and construction phase 1978/82 until the inauguration 1988, the reader is invited to read his paper at: <http://www.oldflames.org.uk> (please look under the history section).

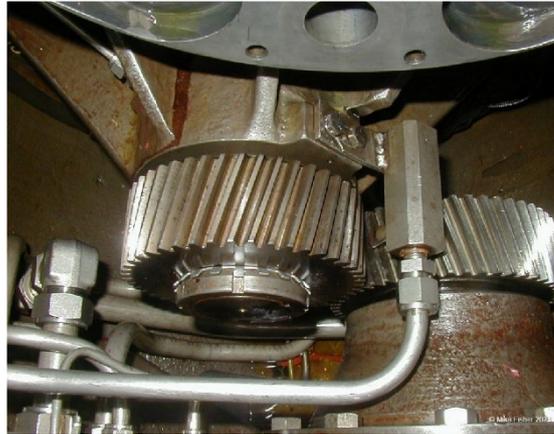
Auxiliary Drive (Partial Image)

The increase in running hours began to “shakedown” the machinery train. Problems developed with the Power Turbine (“PT”) auxiliary drive gearbox (mechanical lube oil pump) on Unit B followed later by PT thrust bearing problems on Unit A. Due to long lead times and very bad winter weather, Unit B auxiliary drive was removed and temporarily blanked off. The AC standby electrical pump would provide all lubrication pressure, the drawback being a failure of incoming AC power would instantaneously trip Unit B. The station continued to provide compression to the NTS, with the benefits of connection to a reliable mains electrical supply and standby diesel 500KVa electrical generator being of particular importance.

A number of other drive failures occurred. These were associated with fatigue failures of the intermediate gearbox shaft, mechanical shaft/gear key failure and pump spline drive excessive wear. Solutions were installed in conjunction with the machinery supplier (Original Equipment Manufacturers (“OEM”)) to overcome many of the above.

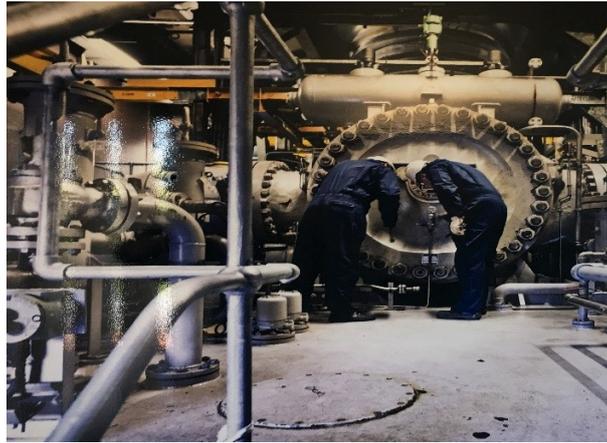
**Warrington Centrifugal Gas Compressor**
